ROUTE AUDIT

Route Number	R60	Direction	Outbound	Auditors	David Griffiths, Stephen Muir	Date	18 April 2010
---------------------	-----	------------------	----------	-----------------	-------------------------------	-------------	---------------

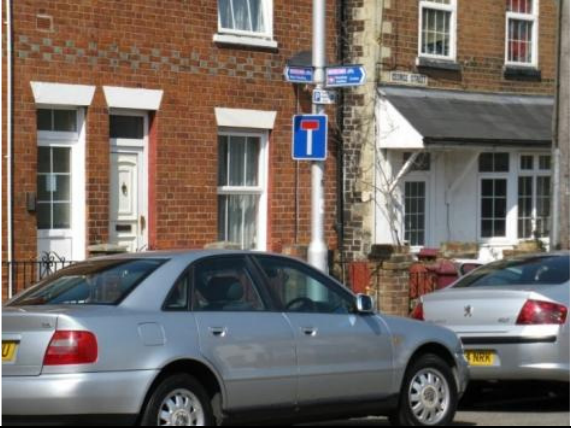
Observations		
Location	Comment	Photo
Junction of Great Knollys Street and George Street	Signs are clearly positioned.

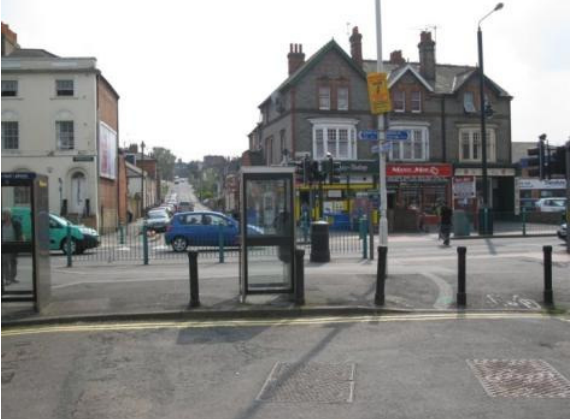
Junction of George Street and Oxford Road	The route crosses Oxford Road, making use of a Toucan crossing. This is not ideal, because of the potential conflict with pedestrians walking along the Oxford Road, but is probably the best solution for this junction. Travelling in this direction the route signs are easy to see, but the cycle marking on the ground is quite worn.

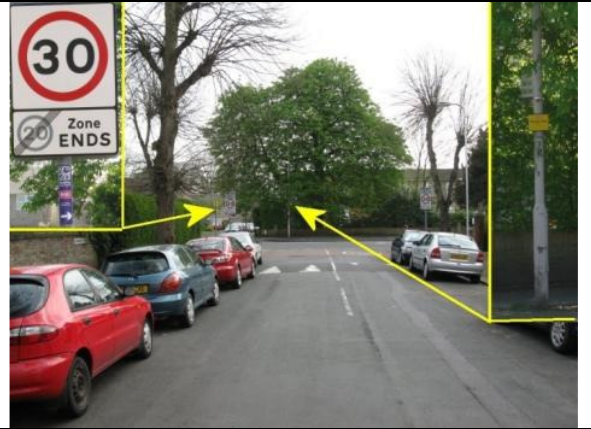
Observations		
Location	Comment	Photo
Junction of Downshire Square and Bath Road	Again, the indication of the turn is a sticker on a lamp post. A proper sign, located a short distance down Bath Road at the pedestrian crossing, would be more conveniently located on the lamp post which is clearly visible to cyclists approaching from Downshire Square.

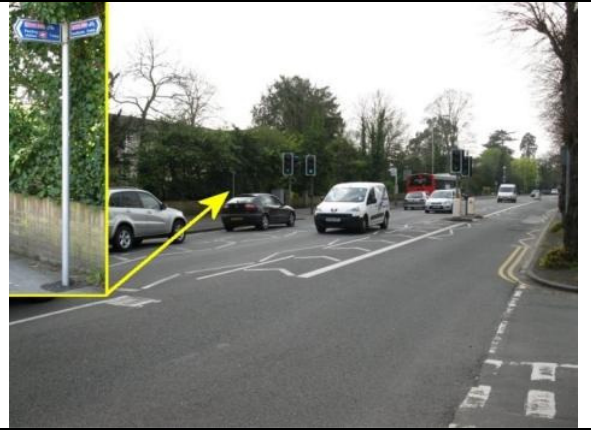
Junction of Downshire Square and Bath Road	This is a tricky junction to negotiate, and may be somewhat daunting for cyclists who are not confident of their ability. Recognising this, the route planners seem to expect cyclists to use the nearby pedestrian crossing to make this turn: thus the sign post is opposite the crossing. However, there's no indication that the cyclist is recommended to use the crossing. (Even so, the sign would be better placed as described in the previous observation, where all cyclists could see it.)

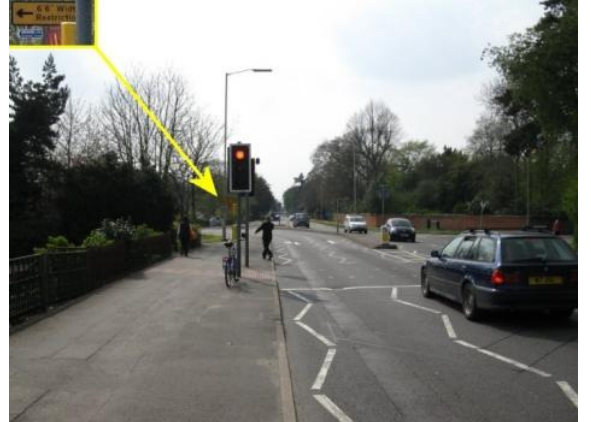
Observations		
Location	Comment	Photo
	/ shared bus lane in this direction. It's actually in the opposite direction. For the last section of Bath Road, the Reading Cycle Map indicates an off-road cycle path; we were unable to see any markings of such a path.	
Junction of Bath Road and Southcote Lane	A route sign is present, but it's difficult to see on the approach to the turn.

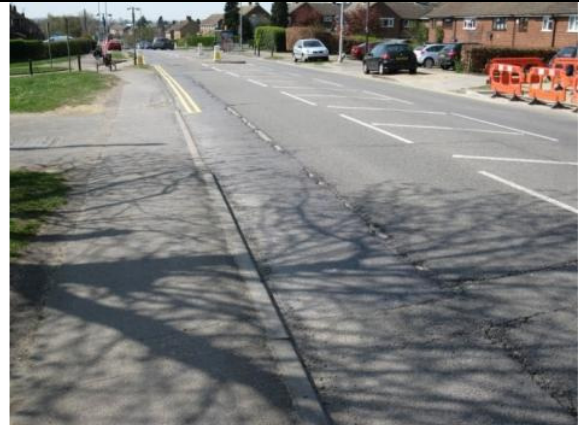
Observations		
Location	Comment	Photo
Southcote Lane	Poor road surface.

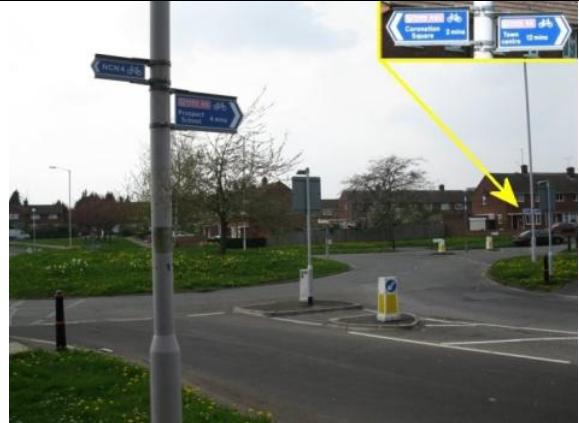
Roundabout at Southcote Lane and Circuit Lane	The route sign is badly positioned.

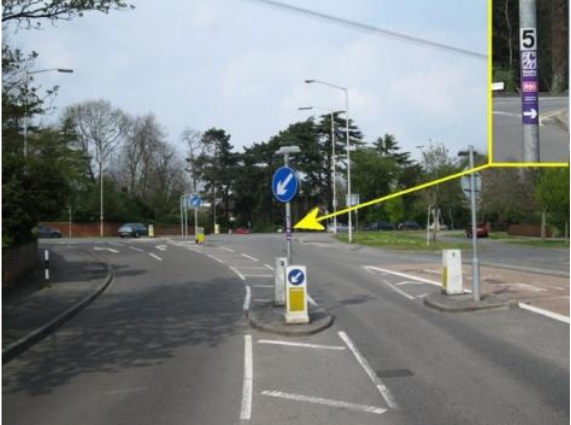
Observations		
Location	Comment	Photo
Roundabout at Southcote Lane and Bath Road	The route sign is a sticker on a post and is difficult to see.

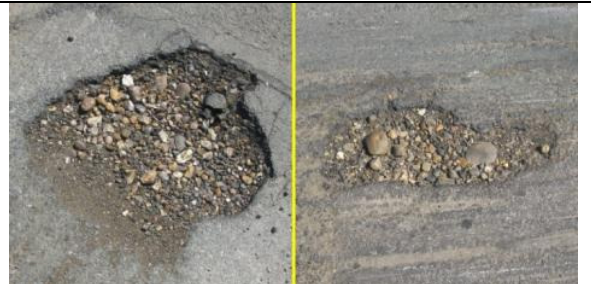
Observations		
Location	Comment	Photo
Brownlow Road	Very poor surface conditions.

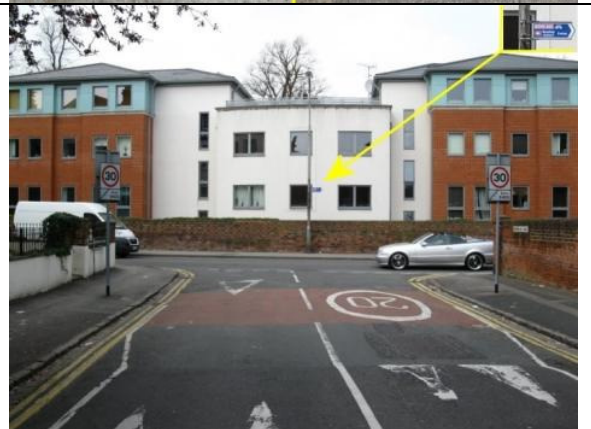
Junction of Brownlow Road and Tilehurst Road	The turn is clearly signposted.

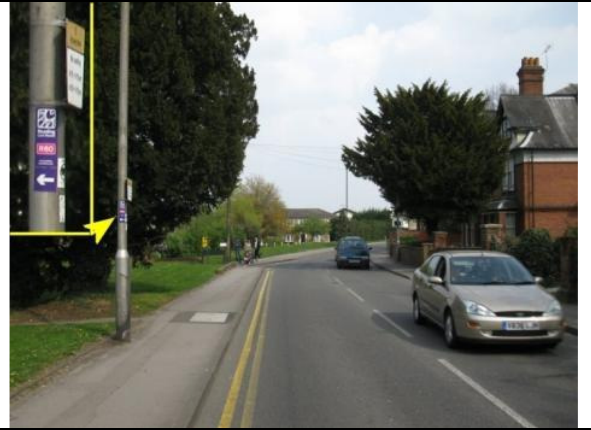
Observations		
Location	Comment	Photo
Junction of Tilehurst Road and Prospect Street	The route sign is a sticker on a lamp post and is very easy to miss.

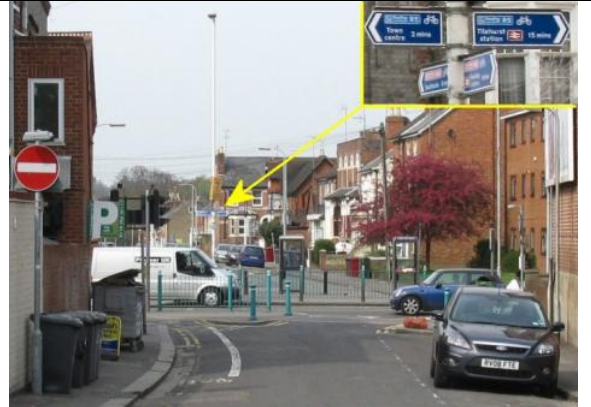
Junction of Prospect Street and Oxford Road	Approaching from Prospect Street, the R60 route sign on the opposite side of Oxford Road is next to invisible. Despite the No Entry sign, it may not be immediately apparent to cyclists that they're intended to filter round to the left and use the Toucan crossing.
