Reading Cycle Campaign

ROUTE AUDIT

Route Number	R10	Auditors:	Keith Elliott, Dougal Munroe	Date	18 th April 2010
---------------------	-----	------------------	------------------------------	-------------	-----------------------------

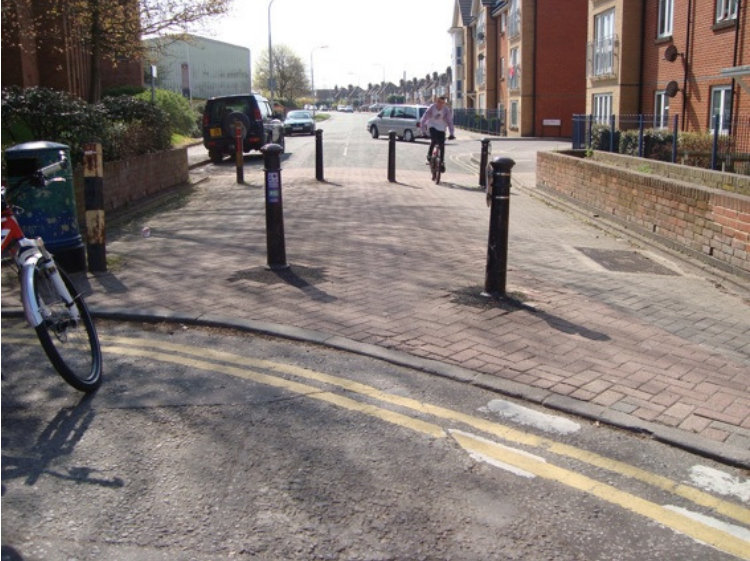
<p>Elgar Rd / Waterloo Rd jct</p>		<p>A drop kerb is required to assist crossing the bollarded road closure. This would also help make the route more legible.</p>

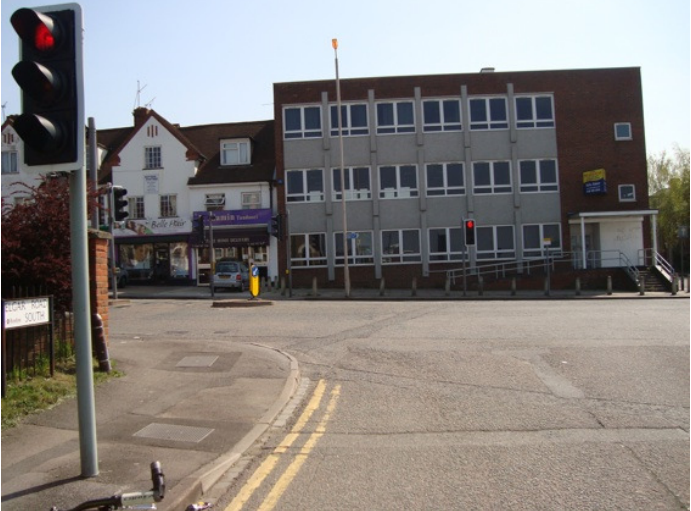
<p>Elgar Rd South / Basingstoke Rd jct</p>		<p>The route sign is on the far side of the junction (east side of Basingstoke Rd); this is hard to see on approaching the junction. The route sign should be on Elgar Rd South close to the traffic lights.</p>

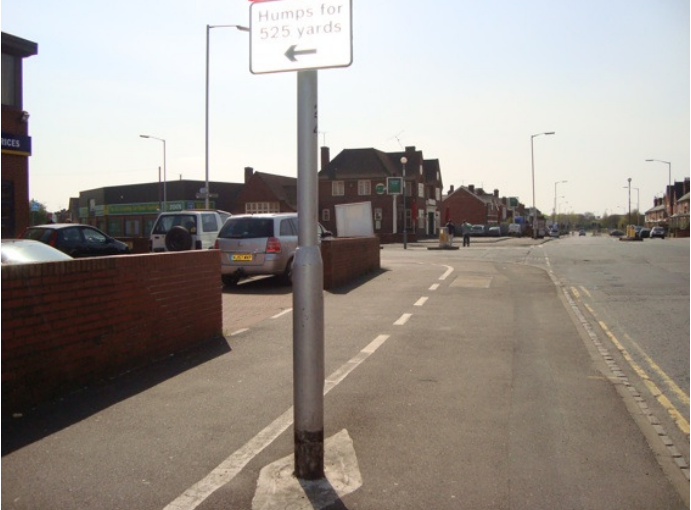
<p>Basingstoke Rd / Long Barn Lane jct</p>		<p>There is no route sign until you have made the left turn into Long Barn lane. A sign is required on Basingstoke Rd</p>

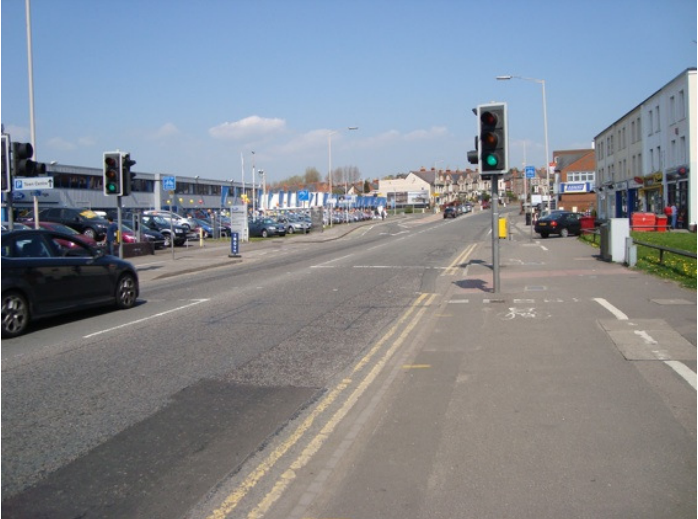
<p>Basingstoke Rd Toucan</p>		<p>Assuming that you are on the shared path, a vinyl sticker should be placed on the Toucan to indicate that you need to cross here to follow the route.</p>

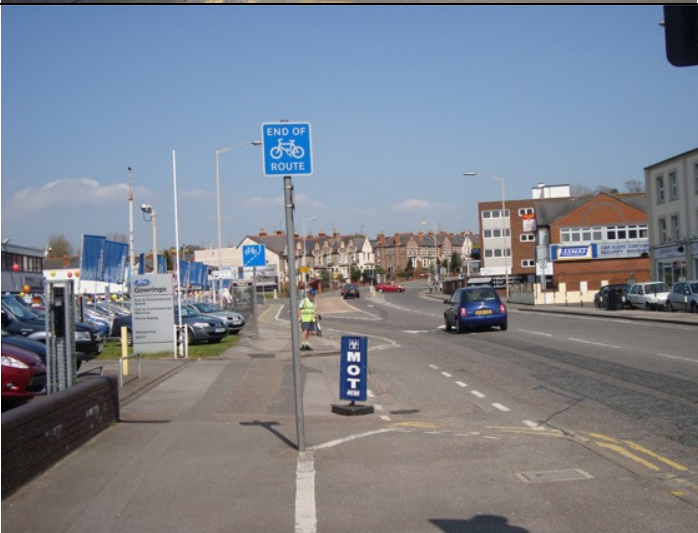
<p>Basingstoke Rd</p>		<p>There is a very short length of shared path on the west side of Basingstoke Rd by the toucan crossing. This stops at the Ford dealers' entrance. An on-road cycle path starts beyond the car dealers. The on-road path should be extended across the dealers' entrance to meet the shared use path.</p>

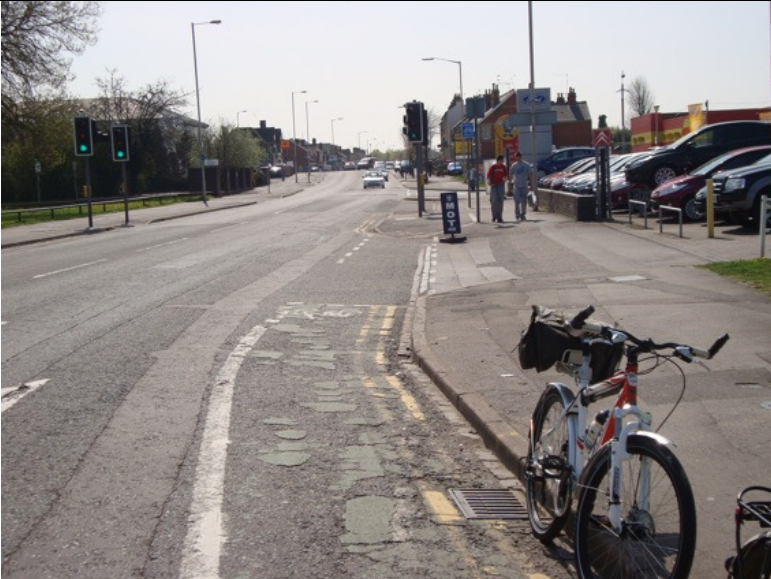
Basingstoke Rd		The on-road cycle path approaching the lights at Elgar Rd south is in poor condition and needs resurfacing.
